PREPARATION AND CHARACTERIZATION OF POLYCRYSTALLINE
HALIDES FOR USE IN HIGH POWER LASER WINDOWS

HONEYWELL INC.
CORPORATE RESEARCH CENTER
10701 Lyndale Avenue, Bloomington, Minn. 55420
Quarterly Technical Report No I
1 April 1972 to 30 June 1972

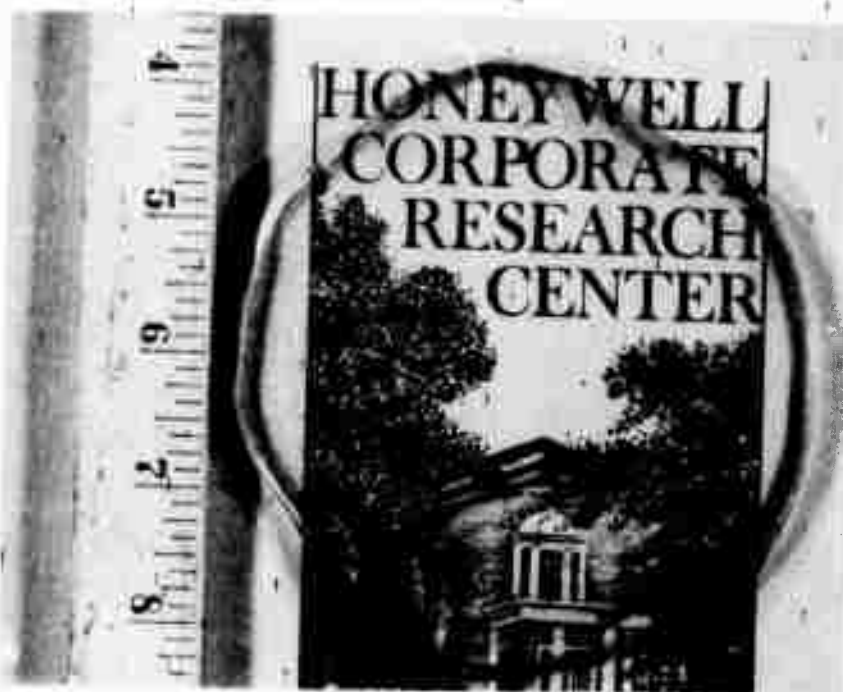
Figure 1. Photograph showing a successful crack free transparent KCl press forging. Forging was carried out at an initial strain rate of $.011 \text{ min}^{-1}$ and at a temperature of 280°C .

To date our most successful press forgings have been made at 300°C at strain rates of .011 and .023 min^{-1} (numbers 19 and 24). Both forgings were crack free and transparent. A photograph of forging number 24 is shown in Figure 1. The forging is slightly oval which indicates a slight inhomogeneity of deformation. This sample has been examined in polarized light

and the observed birefringence indicated the residual stresses in the forging to be quite uniform. A photograph of forging number 21 showing the radial cracks mentioned in Table 1 is included in Figure 2.

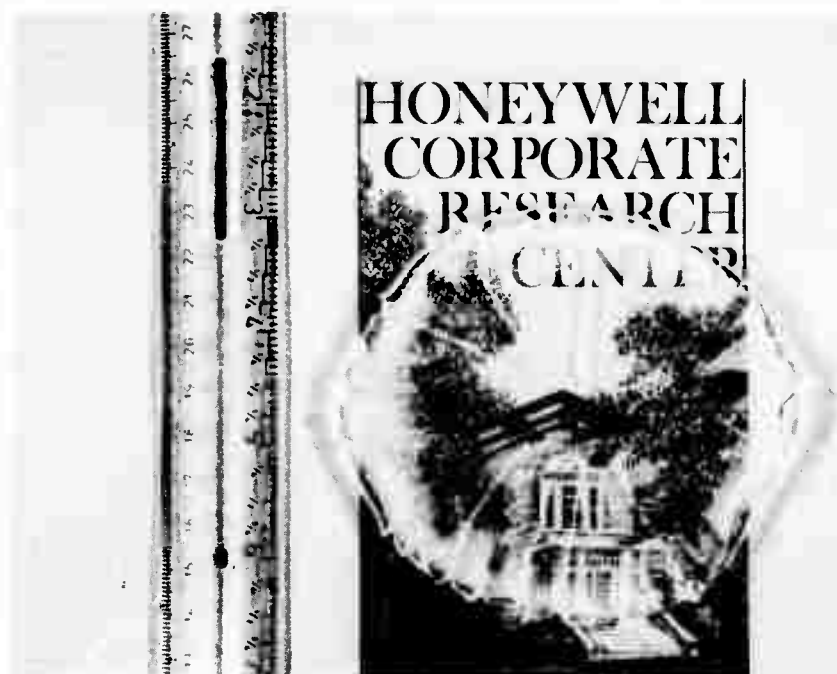
Figure 2. Photograph showing a KCl press forging containing radial cracks. The irregularities at the outside edge of the forging indicate the cracks may have originated from surface flaws in the initial billet. Forging was carried out at an initial strain rate of $.011 \text{ min}^{-1}$ and at a temperature of 190°C .

As noted in the comments in Table 1 many of the forgings cracked. The fractures originated from a number of causes, most of which we feel can be controlled. First, when working at constant ram speed, the increasing strain rate leads to work hardening and a flow stress which might exceed the fracture stress of the forging. This can be controlled by pressing at a constant strain rate as done in forging number 29. Second, it is important to have flat and polished platens. Both excessive friction and flaws in the platens can initiate cracks. Third, any internal cracks in the crystal (e.g., resulting from cleavage) can propagate during forging. This was the case in numbers 21, 25, 27, and 29. We had been water polishing the last few billets, but evidently not to the extent required.

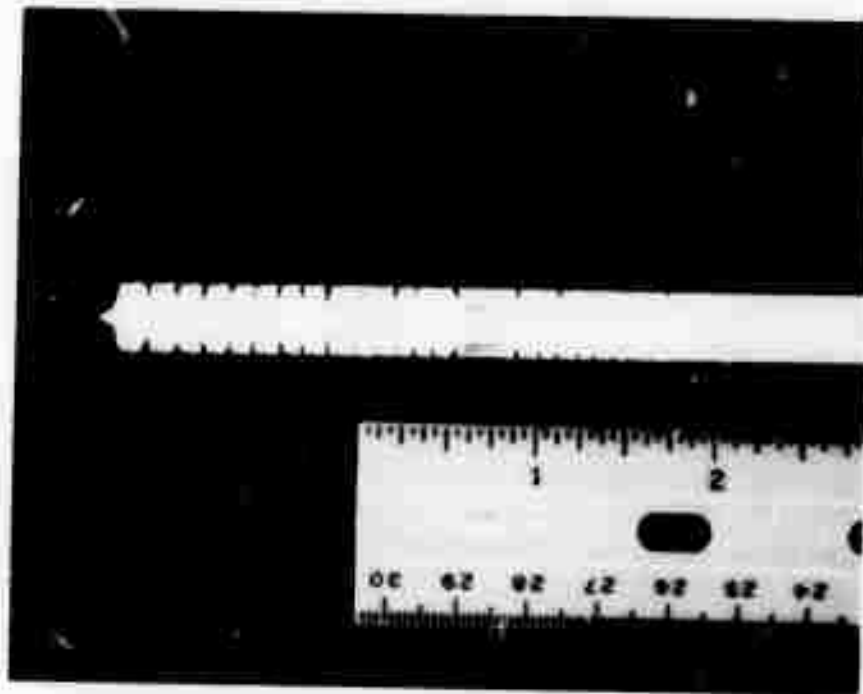
Figure 3. Photograph showing extrusion resulting from excessive die friction. (Extrusion number 1. See Table 1.)

($\ln 16$) times the ram speed. At 400°C no problems were encountered and the extrusion (excepting the first 3 inches) was transparent and had a good surface. Rattailing is a common extrusion defect and occurs when die friction is excessive. An example is shown in Figure 3. A photograph of an extrusion exhibiting a good surface is shown in Figure 4.

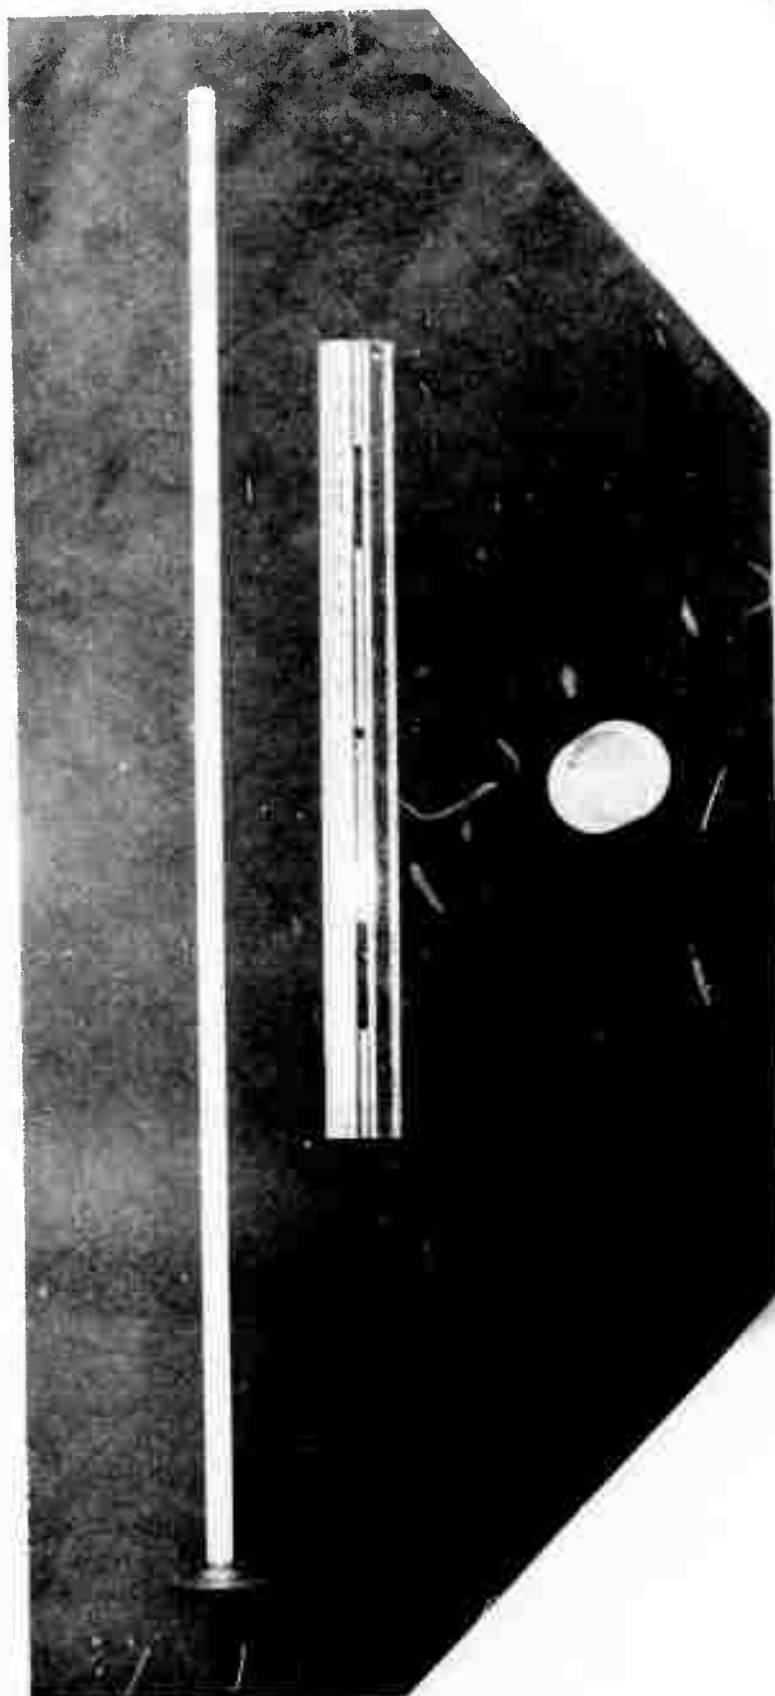
Figure 4. Extrusion showing an extrusion having a good surface finish. Extrusion number 23. (See Table 1.) The extrusion is somewhat cloudy. Billet identical to one used for extrusion also shown.

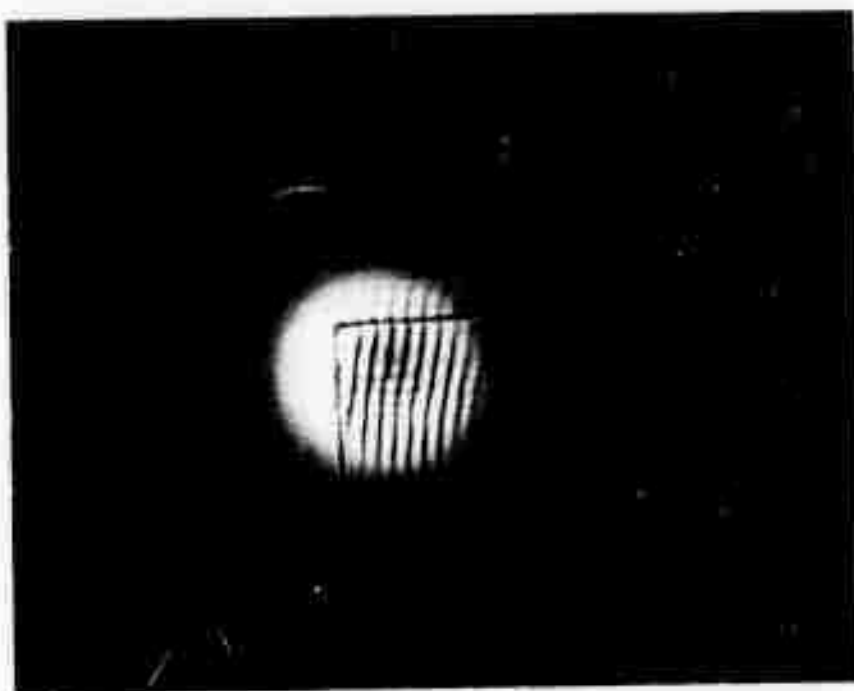
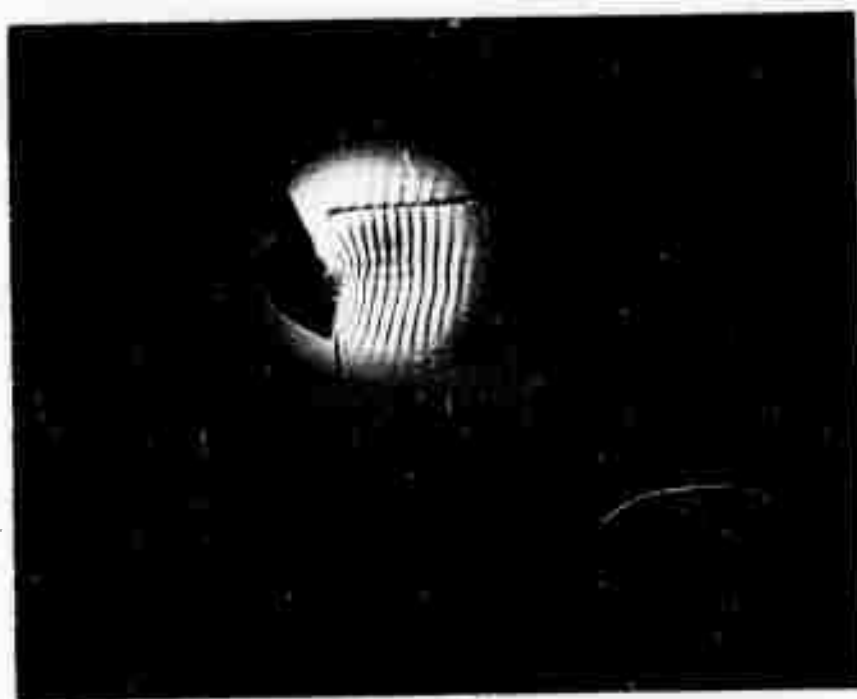
Figure 5. Changes produced in holographic interferogram of NaCl window when heated with a soldering iron. a) original interferogram; b) interferogram with soldering iron on window.

Using the interferometer we have examined the deformation of the holographic interference pattern resulting from the application of a soldering iron to a 5mm thick sodium chloride window. The results are shown in Figure 5. To date we have not been able to produce any detectable alteration of the interference pattern by illuminating this window with a 10 watt CO₂ laser. We now have put into operation a 70 watt CO₂ laser and expect to be able to produce measurable changes with the higher power. Changes in the optical path in quartz windows irradiated with a 3 watt CO₂ laser have been observed and are shown in Figure 6.

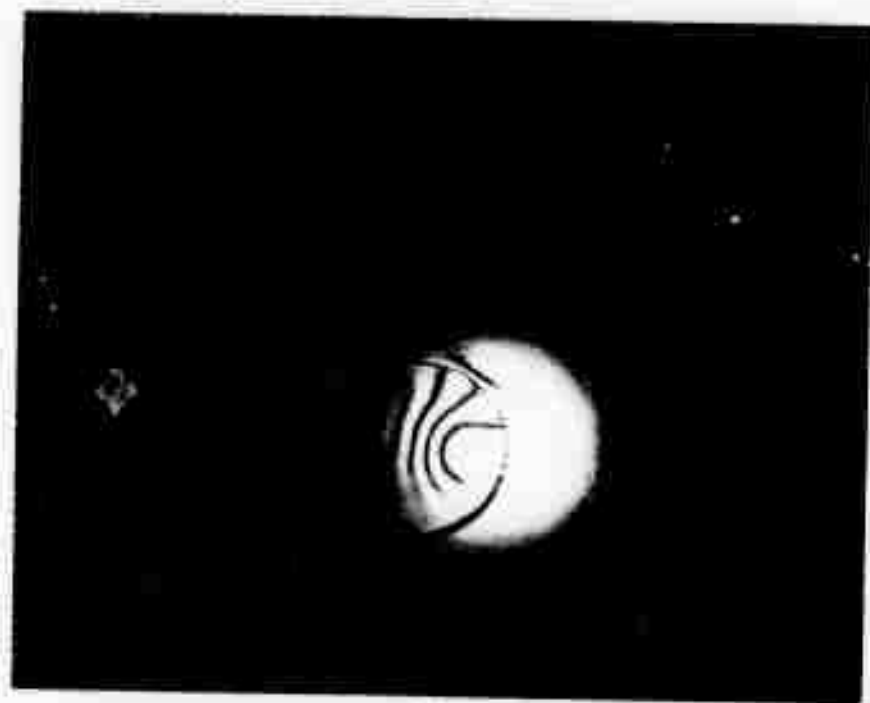
Figure 6. Changes produced in interferogram of quartz window when heated near edge with a 3 watt CO_2 laser. a) original interferogram; b) interferogram after 30 sec. exposure to laser.
